I.2: Renovation of Sukhniwas Palace

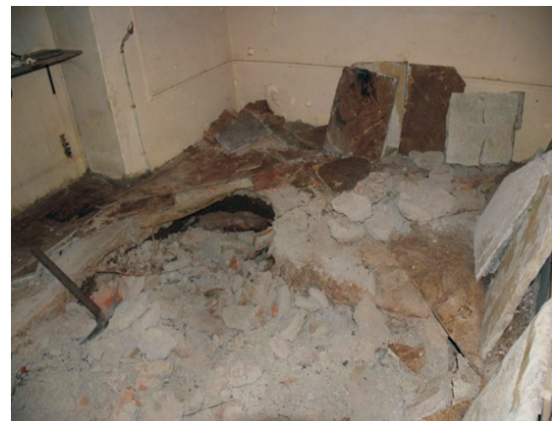
existence of weathered rock layer over hard strata. The load bearing wall of thickness 600 mm did not show any sign of distress, indicating its sound structural health. However the basement floor indicated significant settlement at many places. The trial pits indicated black cotton soil and hollow space below the floor. Thus, it was concluded that black cotton subsoil was subjected to volume changes. The fluctuation of water level in the adjoining lake led to the moisture movement and consequent expansion and contraction of sub base. Due to intense seepage of lake water in the building, the floor started settling, posing great threat to stability of the structure. Figure I.2.2 shows the damaged hollow floor as proof of settling of the floor. In order to arrest seepage, RCC cut off wall is constructed up to the depth necessary for stability of foundation. Incidentally the deepest point of lake is close to the palace, hence the construction of cut off wall under water was challenging. Cofferdam was built to restrict the water flow. Construction and dismantling of coffer dam was also a challenging task.

Fig. I.2.2: Damaged hollow floor.

The floor sub base is reconstructed with designed sub base in layers, considering the moisture movement. The reconstruction of basement floor includes provision of box type RCC slab designed to withstand upward soil pressure. Red stone flooring is provided over the RCC slab. Figure I.2.3, is a cross sectional view of the box type slab and the floor after renovation.

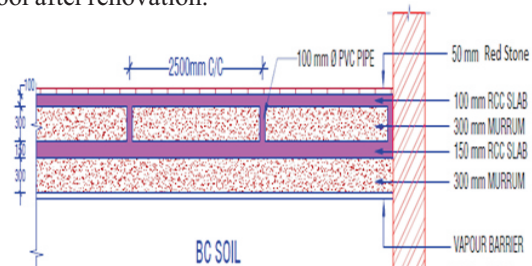
Fig. I.2.3: Cross-section of box type slab and floor.

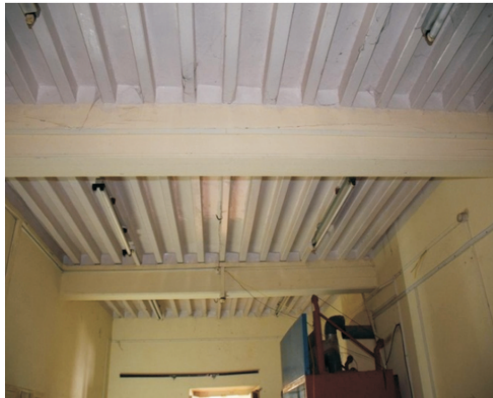
It was also observed that there is a deflection of the wooden beams as shown in Figure I.2.4. In view of the deteriorated wooden beams, scantlings etc., old available structural steel frame work with old weld mesh is provided on the soffit of roof to increase its stability. Further, in order to restrict the entry of rain water, low height metallic roof is also provided.

Fig. I.2.4: Deflection of wooden beams.

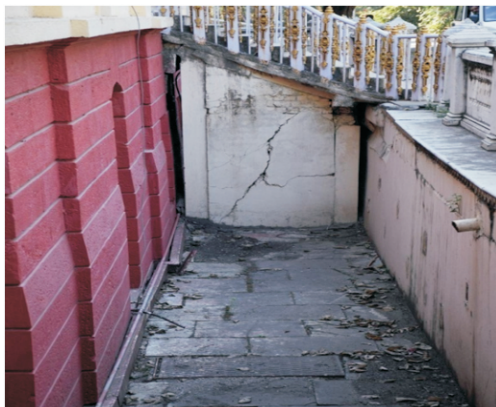
C) Entrance stairs, lobby and retaining wall: The entrance stairs were supported on RCC structure exhibiting signs of cracks and distress due to settlement of the building foundation. Also, the cracks were noticed in the retaining wall along with de-bonding of plaster. The paved space in between basement wall and retaining wall was also settled at some places and showed uneven surface joints. This is shown in Figure I.2.5.

Fig. I.2.5: Side view of entrance staircase.

Entire structural work of retaining wall and waist slab is retrofitted by providing cantilever waist slab supported on newly constructed RCC retaining wall. Figure I.2.6 shows a view of the retaining wall after renovation. The retaining wall is also provided with weep holes to drain out sub soil water from the embankment of road. RCC retaining wall with marble railing similar to the existing pattern is also provided for better aesthetics. Internal electrification work along with lightning arrester have also been carried out in consultation with the State Government authorities.

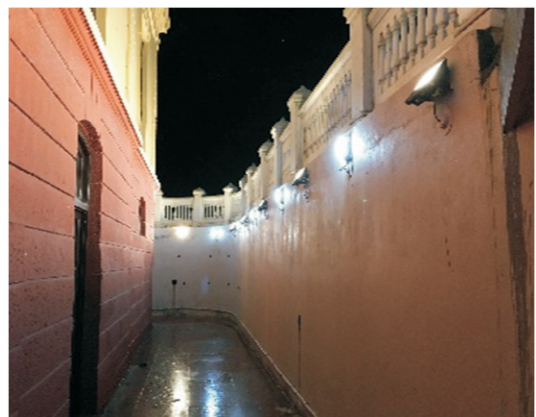
Fig. I.2.6: Retaining wall after renovation.

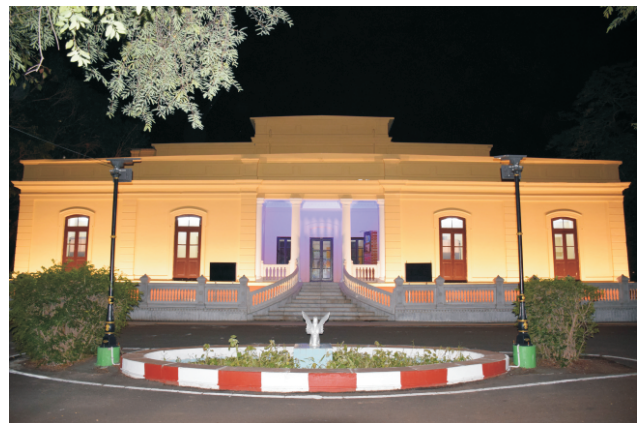
Fig. I.2.7: Palace after complete renovation.

Figure I.2.7 shows the front view of Sukhniwas Palace, after complete renovation. After the completion of renovation work, the authorities of Archeology, Records & Museum Government of Madhya Pradesh have issued a certificate indicating satisfactory completion of the work and asserting its fitness for intended use.
