A.5: Investigation on Failed Septum Magnet Coils of Indus-2

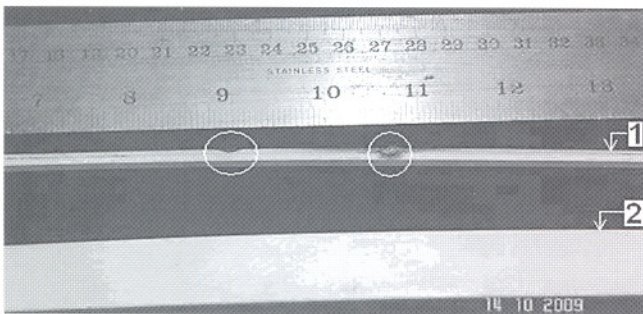
The failure of septum coils was noticed in the form of arcing at different locations in thin section of the coil. Defect locations were marked with removal of alumina coating with or without signs of localized surface melting (Fig. A.5.1). Failure sites were associated with abrupt transition in cross-section along with internal and external 90° corners. Alumina coating on the external 90° corner was found to be associated with lack of bonding while machined notch provided at the inside 90° corner remained poorly filled with numerous cracks and lack of bonding (Fig. A.5.2).

Fig. A.5.1: Defect locations (encircled) in the failed septum magnet coil. Thin and thick sections of the coil are marked as "1" and "2", respectively

On the basis of the results of the study, it was inferred that no notch should be machined at the internal 90° corner of the coil while sufficient rounding (radius ≥ 0.75 mm) should be provided on the 90° corner edges. The inclination of specimen's surface with respect to spray direction strongly influences adhesion, thickness and porosity content of the coating.

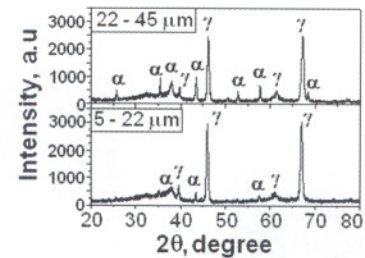
Characterization of detonation-sprayed specimens demonstrated that the coating deposited with fine alumina powder (5-22 μm) was associated with relatively larger degree of melting and lower surface stress, although with largely similar hardness and porosity contents, as compared to that deposited with coarser alumina powder (22-45 μm). Relatively lower amount of α-Al₂O₃ in the coating, deposited with fine powder (Fig. A.5.3), is indicative of relatively higher degree of melting. In alumina-coated profiled specimens,

Fig. A.5.3: X-ray diffraction patterns of alumina coatings deposited with powders of different particle size

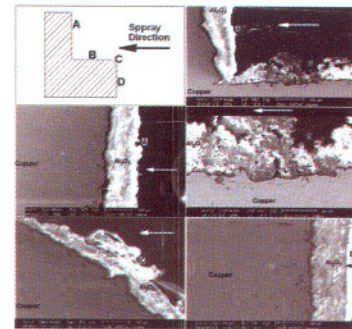
surface normal to the spray direction exhibited thick and well-bonded Al₂O₃ coating while surface parallel to the spray direction carried highly porous and loosely bonded coating. The coating exhibited discontinuity at internal 90° corners. On the curved surface, thickness of Al₂O₃ coating continuously varied with change in inclination of the surface with respect to spray direction (Fig. A.5.4).

Fig. A.5.4: Cross-section of profiled Al₂O₃-coated copper specimen. Spray direction is marked with arrow
